Lessons learned in the implementation of the Buzzards Bay Stormwater Collaborative effort to  
map and monitor stormwater discharges

Preliminary draft

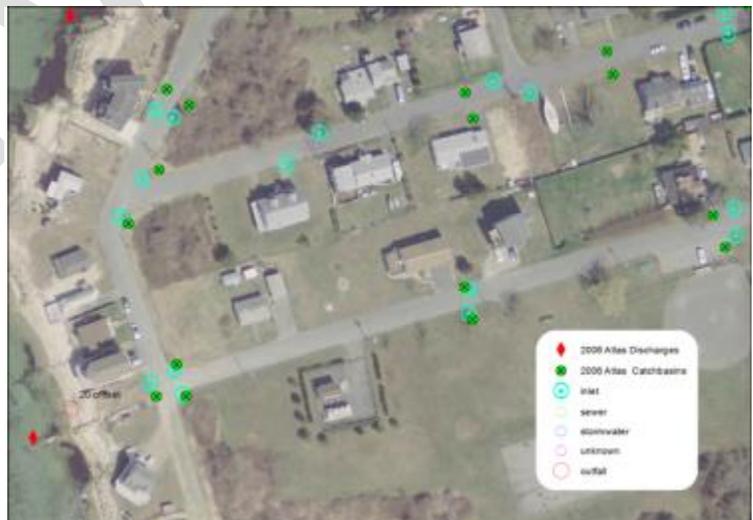
Fig. 3. The location of previously mapped features were verified, and new features added for the catchments of all priority discharge sites defined in the grant workplan.

**GIS Database:** Stormwater networks were mapped throughout each town, focusing on connections to priority discharge pipes. Road and development plans were scanned, and entered into a digital file, and provided to each town. The effort involved verifying and updating previously mapped stormwater infrastructure features, or adding new ones (Fig. 3), as well as adding pipe layouts from scanned and georeferenced plans.

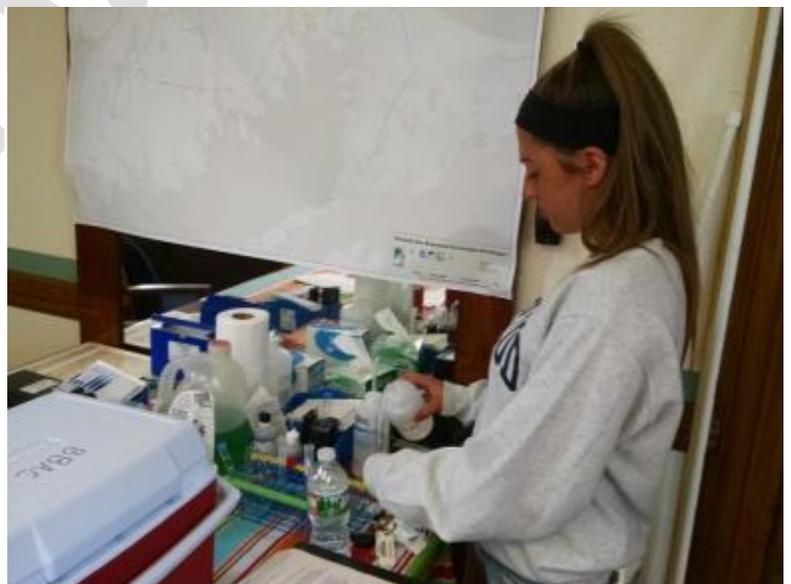
Fig. 4. BBAC intern testing a stormwater sample with one of the test kits.

additional in-office testing (Fig. 4), and laboratory testing principally for bacteria. A full list of parameters are shown in Table 2. Methodologies are detailed in the [project QAPP](#).

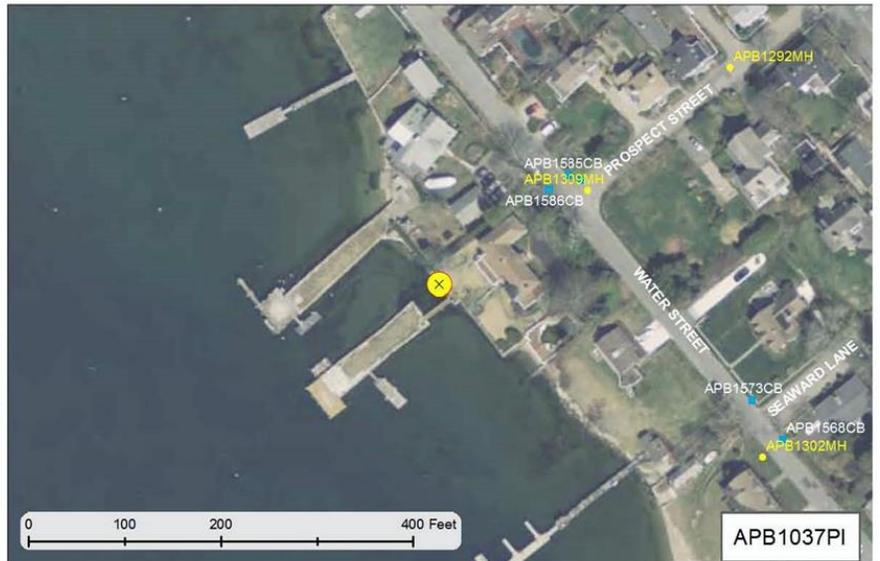
DW: no issues. WW Mod to high levels of Bact and elevated Nitrates, Amm, and Surf. WW rank Bact (2), Nitrates/Amm/Surf (1 ea), Tot 5. App Bay Impair: Bact and N

Fig. 5. Sample report for a stormwater discharge.

**Technical Report:** The Buzzards Bay NEP is preparing a 270-page discharge report summarizing the findings collected under the EPA grants. The core of the document is a summary page for each discharge that includes a description of the discharge, a map of its location, sampling locations, and data collected. Areas of concern will be identified which enable towns to focus remediation efforts on priority discharges. Fig. 5 shows a representative summary page for a discharge located in the Town of Dartmouth. These discharge summaries are also made available on the [Stormwater Collaborative Interactive Map](#) available online so that the public and government officials can navigate to any location and display information about the discharge.

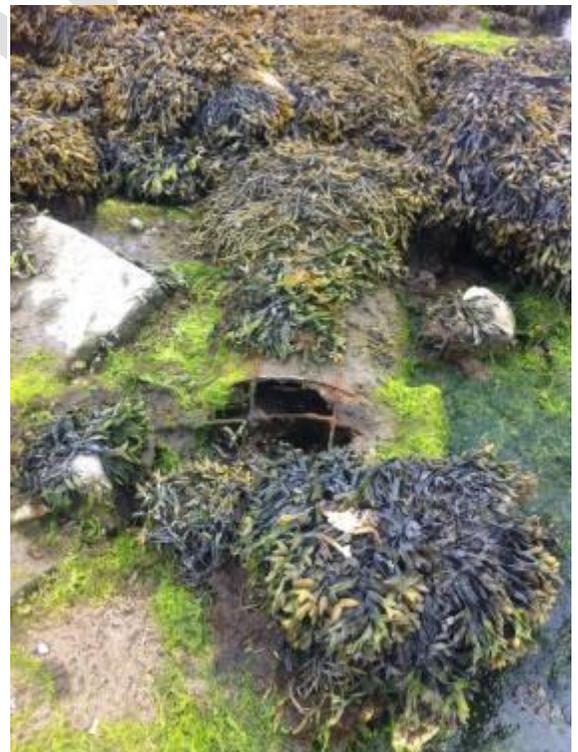
Fig. 7. Many discharges are intertidal or subtidal. Even when they can be sampled at low tide, the sample may be mostly salt water that intruded into the pipe.

Monitoring stormwater discharges in the coastal zone represents a special challenge because pipes are located in the intertidal zone (often the low intertidal zone) or subtidal (Fig. 7). Thus, unless a rainfall occurs during low tide, it may be impossible to collect a sample at the end of the pipe. Even if tides are favorable and the pipe is exposed, salt water intrusion into stormwater network means samples are not necessarily good indicators of the stormwater network contaminant levels and the presence of salt can require changes in analytical methods used to test for certain contaminants.

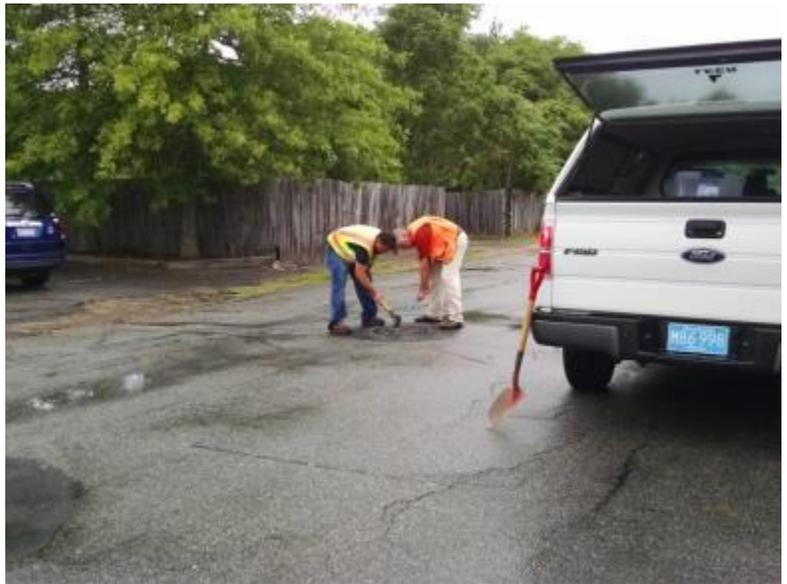
Fig. 8. Manhole covers must be removed to confirm network connections and for sampling.

These challenges required that sampling in most networks be undertaken at the first or second manhole upgradient of the stormwater discharge (Fig. 8). This not only required participation by municipal public works staff, but also severely limited how many sites could be practically sampled during any particular rainfall. It also required that stormwater networks be mapped so that the correct corresponding manhole locations are known, and the various pipe junctions under the manhole be identified before stormwater sampling began. This requirement is so essential, that any similar monitoring program should have mapping be the focus of start-up efforts. To a degree, the drought during the summer of 2016 provided the Stormwater

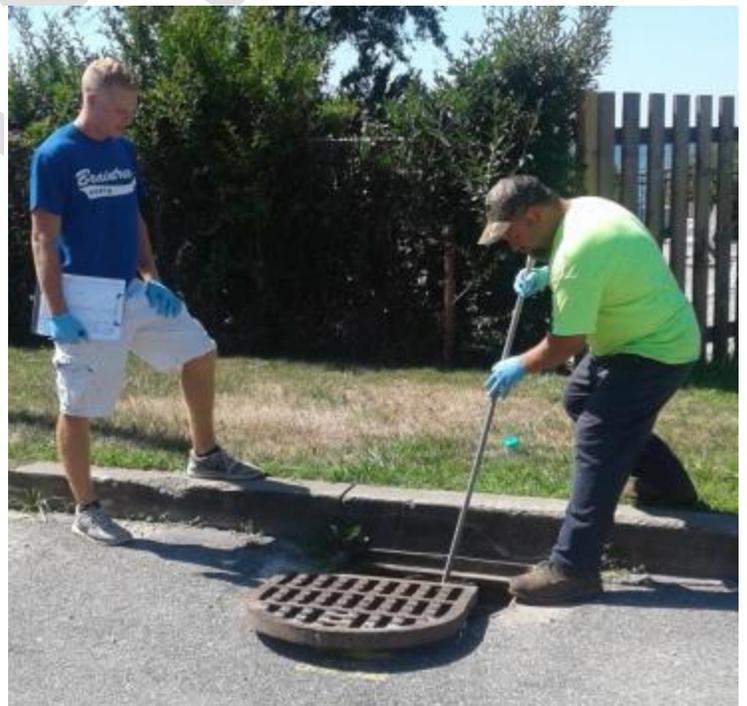
Fig. 9. BBAC intern working with DPW crew to collect water samples.

Even when stormwater facility networks are well mapped, and sampling locations defined, the efficiency of sampling (Fig. 9) can be enhanced by planning routes in advance with multiple stops to get a better sense of route duration. Free online tools also allow importing multiple latitude and longitude coordinates to provide street directions. The Buzzards Bay NEP's interactive stormwater network map has a directions feature that will call up a smart phones mapping app to get driving directions to any location. Staff have to be made aware and trained in the use of these tools. As noted above, pre-inspection of monitoring sites is important to determine if pipes or system junctures need to be cleared or serviced before sampling hours.
